## **Identifying and Dealing with the Causes of Water Shortage in Lagam Escarpment of Kerio Valley, Marakwet District, Kenya**

Journal of Emerging Trends in Educational Research and Policy Studies (JETERAPS)

Loice Jepkemboi Kipkiror

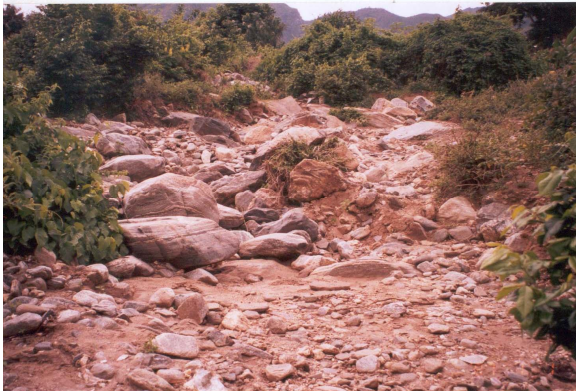
River Embosumer, shown on Plate 1 below, is one of the rivers that have dried up in the area of study mainly due to deforestation on the highland plateau besides sedimentation. On the other hand, Embobut River, which is one of the main rivers in the area of study, is also on the verge of bowing out of existence. In the case of River Embobut though, the culprit of river extinction is not only deforestation but also increased river water diversion via furrows and deposition of sediments by water runoff on the Lagam escarpment. Currently, Embobut River appears as shown on Plate 2 below, which is a far cry of what it was some years earlier. It should be noted

that water pollution is also evident from the photograph, especially the presence of children bathing in the river.

Plate 1: The Dried Up Embosumer River

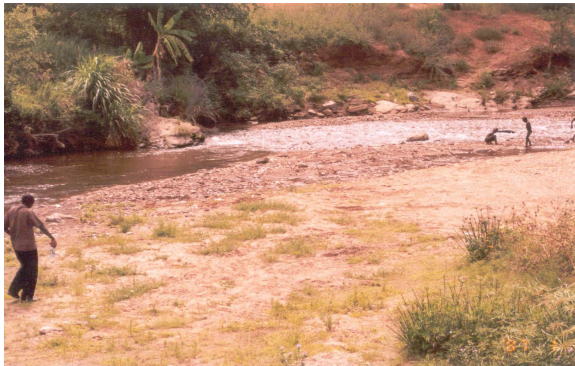
Plate 2: The Dried Up Embomut River

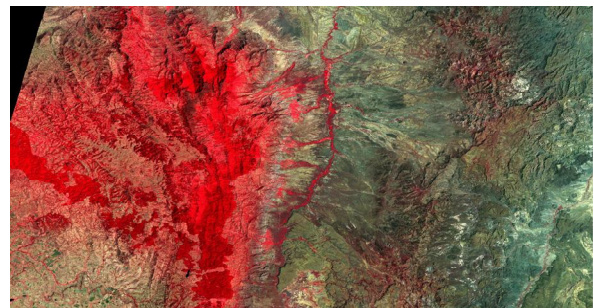
Here, active water bodies were assessed in terms of numbers without necessarily looking at their area coverage. From the Landsat thematic mapper images shown below (Plates 6 and 7) change in the density of water bodies can be seen between 1986 and 2000. In 1986, for instance, and according to the Landsat TM P169R059 of January 1986, the number of active rivers seems to have been more noted by the number of streams joining the Kerio River. The Lagam escarpment also seems to have had many active streams dissecting it and must have boasted of dense vegetation as seen by its brightness in the red section. In 2000 (Landsat TM P169R059 of January 2000), the area shows lots of change though the image seems to have been taken during a time of heavy precipitation. Streams and rivers appear to have decreased in number with some even bowing out of existence. This can also be confirmed from plates 3 and 4 used elsewhere in this paper where rivers

which were active in 1986 (AR) ceased to be active in 2000 as they dried up (Dry Rivers - DR). In the 1986 image thus, there are about thirteen countable rivers that drained river Kerio from the area of study as compared to only about ten reaching River Kerio in 2000.

Plate 6: False Colour Composite of Landsat TM P169R059 - Jan1986 depicting Kerio River Regime Scale 1: 300,000
